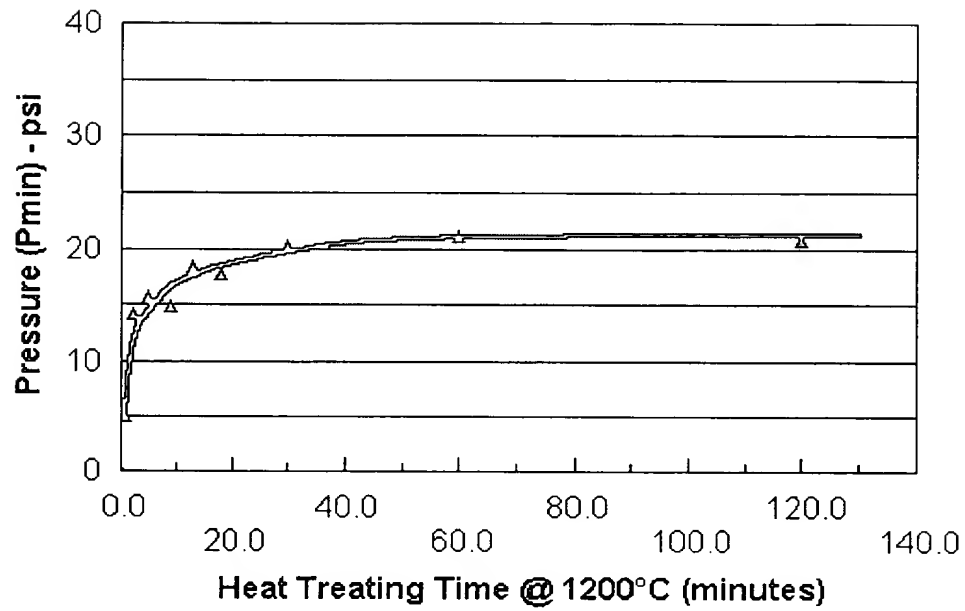
Figure 8

1000 Cycle Test

Pmin1000 vs. Heat Treating Time at 1200°C

Gap Expansion = 7%
